Drilling - Field Test Report

Test Summary Success[over 110%] (X) / Equal[100~110%] () / Failed[Under 100%] ()

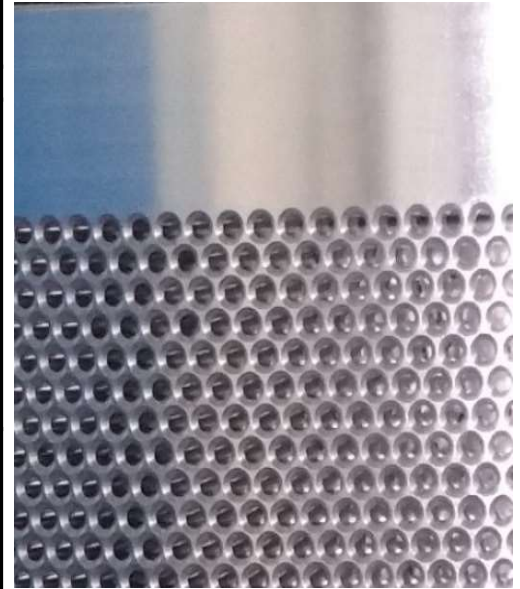
| Machine information | Maker | | | Picture see RIGHT. The part are filters | |

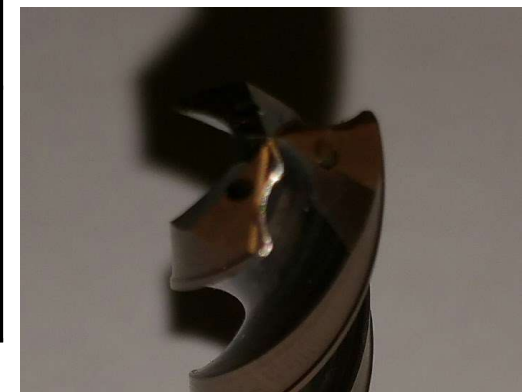
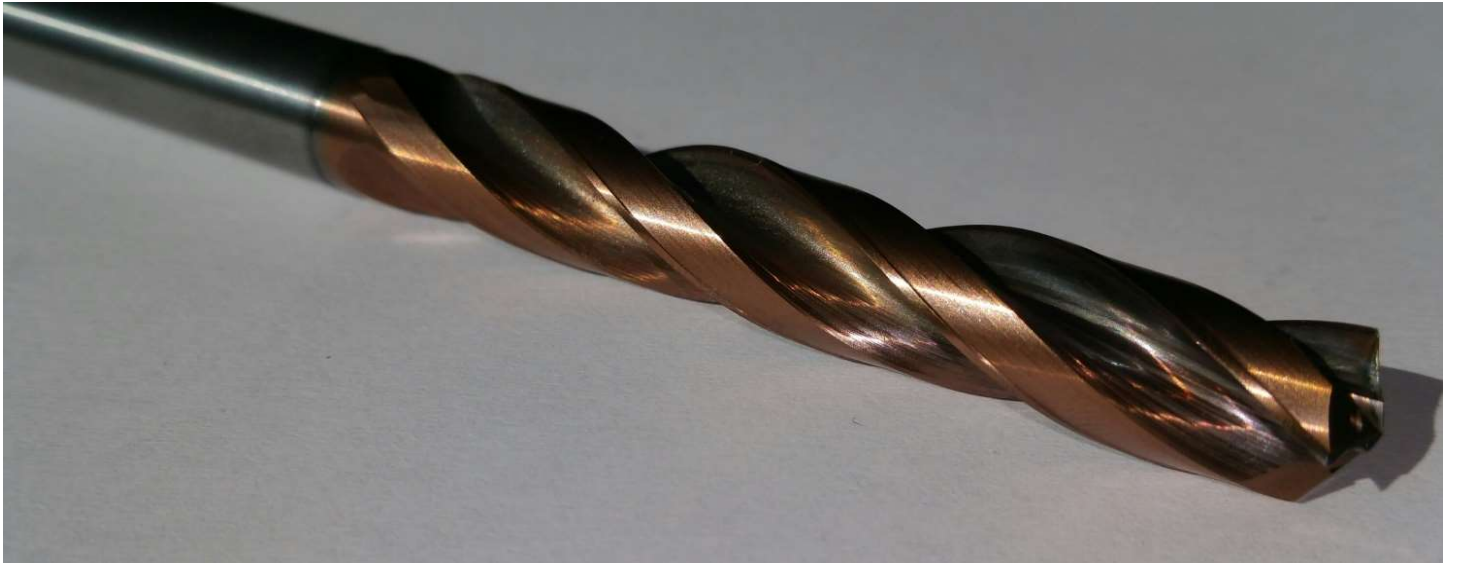
| Wear (um) | | um | see picture | um | see picture | um | see picture | um |
| Type of wear | | | see picture | | see picture | | see picture | |

The complete filter was done with 1 tool, without burrs and good chip breakage. The result was definitely better than DREAM DRILL GENERAL. Because there is 1 more tooth, the power is a little bit higher and, in the middle of the filter, was some noise. but not risk and good machinability.
